MARYLAND HISTORICAL TRUST	LAND HISTORICAL TRUST  SURVEY NUMBER:  45-8				
21 STATE CIRCLE SHAW HOUSE	NEGATIVE FILE NUMBER:				
ANNAPOLIS, MARYLAND 21401					
	UTM REFERENCES:				
HISTORIC SITES SURVEY FIELD SHEET	Zone/Easting/Northing				
ndividual Structure Survey Form					
	U.S.G.S. QUAD. MAP:				
PRESENT FORMAL NAME:					
COUNTY. Anno Anno dol	OD TOTAL				
COUNTY: Anne Arundel TOWN: Annapolis	ORIGINAL FORMAL NAME:				
LOCATION:	PRESENT USE: Commercial				
138-142 Dock St.	ORIGINAL USE: Commercial				
	ARCHITECT/ENGINEER:				
COMMON NAME:					
Steven's FUNCTIONAL TYPE: COMM Map 33 Par 73	BUILDER/CONTRACTOR:				
OWNER: Steven's Inc	PHYSICAL CONDITION OF STRUCTURE:				
ADDRESS: 142 Dock St.	Excellent() Good(*)				
Annapolis, MD 21401	Fair() Poor:()				
ACCESSIBILITY TO PUBLIC:	THEME:				
Yes(x) No ( ) Restricted( )	STYLE: Victorian Commercial				
LEVEL OF SIGNIFICANCE: Local() State () National()	DATE BUILT:

Form 10-445 (5/62) 1. STATE Annapolis, Maryland county town vicinity street No. 142 Dock Street

HISTORIC AMERICAN BUILDINGS SURVEY
INVENTORY

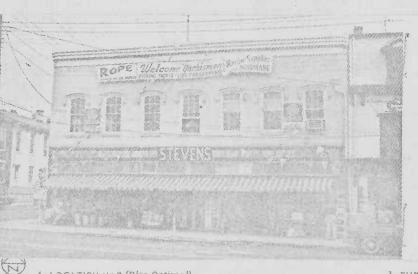
Constance Werner Historic Annapolis, Inc. 7. PHOTOGRAPH

Stevens Hardware Store occupies a rather grand, simple, yet dignified Victorian commercial building. The 1st floor store front has been redone in 1940s vintage imitation marble glass. The building above the store is completely unaltered. There are seven 6/6 eliptical windows with granite sills and topped by protruding header brick drip moldings. The cornice is a simple extended one with a floral bracket at each end. The Randall Street side presents a large brick area, which has an advertisement printed on it; such painting can be attractive and should be the only kind of large scale advertisements allowed in Annapolis. A good example of the Civil War period, this handsome building is an important component of the Market Space.

Exterior good

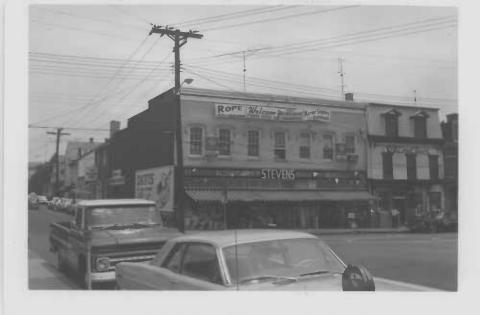
742 DOCK ST.

PHOTOGRAPH BY WILLIAM D. MORGAN

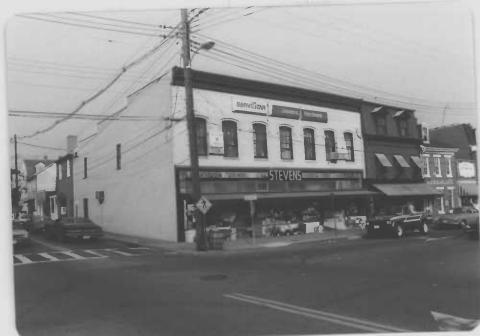
Annapolis, Anne Arundel County
Russell Wright July, 1982
Maryland Historical Trust,
Annapolis, Maryland
SW Elevation/camera facing NE

Pressed metal cornice; segmental second floor windows with drip molds; c1940 shopfront with imitation marble and Carrera glass.
